Appendix G : Case Studies

Case Study 1 – Manufactured Home

Unit Type: Single-Wide Manufactured Home
Client Address: Wilmington, New Hanover County, NC

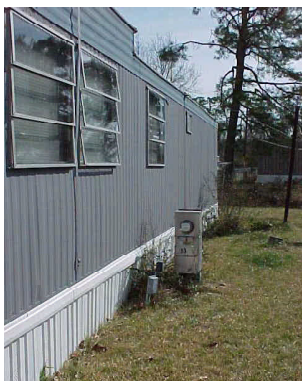
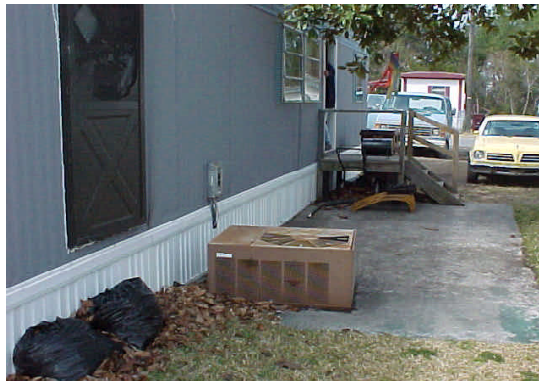
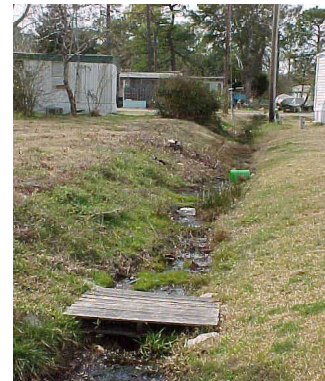
The blower door test results indicated the home had considerable air leakage. Leakage was found around the front door frame, where the original door had been replaced and around the second door that was improperly sized in a poorly fitted frame.

Broken and missing windows in the home also made a significant contribution to the poor blower door readings.

After completing the blower door test and furnace inspection, the Inspector decided that there were opportunities to use WAP funds to improve the energy efficiency of the home. Weatherization measures to stop air infiltration included the installation of doors and windows, and applying caulking, roof cement and

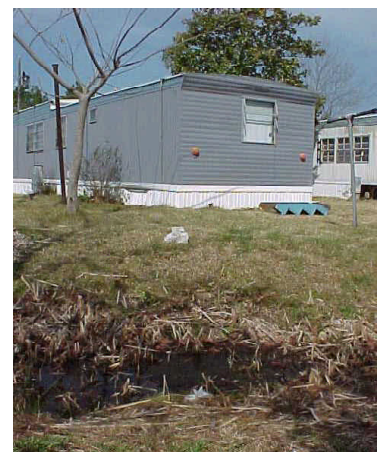
opportunities. The review focused on the higher risk wind hazard and included checking whether the mobile home was properly strapped and anchored. The home had standard “over the top” style straps, but a number of them were not adequately secured and were loose when pulled by hand.

The Inspector looked under the home to inspect the anchoring of the straps to the frame of the home and to the ground. The anchoring was adequate and used standard ground anchors that were appropriate for the conditions expected.

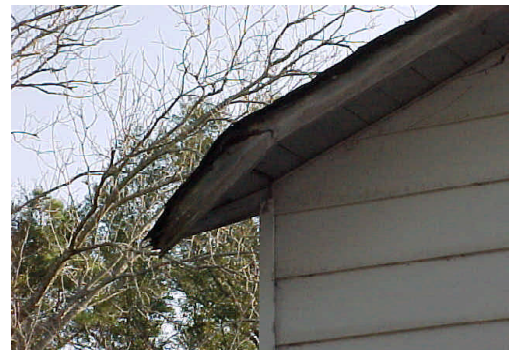
When the Inspector examined the inside of the home, he found that the door to the plastic-enclosed porch area was permanently open, so the energy efficiency of the home was further reduced. The Inspector decided to install doors on the porch and reduce air infiltration. The Inspector also recommended that attic insulation be installed. To help eliminate air infiltration, he further recommended applying minor glazing, caulking, and roof cement. The Inspector estimated the types and quantities of materials required to make the weatherization improvements to the home.

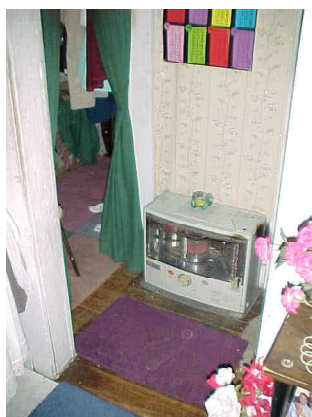
When the Inspector examined the furnace and interior heating systems, he found the client used unvented kerosene heaters as the sole heat source. The inefficient heaters were expensive to operate and were a safety hazard. Therefore, the Inspector recommended that the client receive a gas space heater to provide adequate, safe heating for the family.

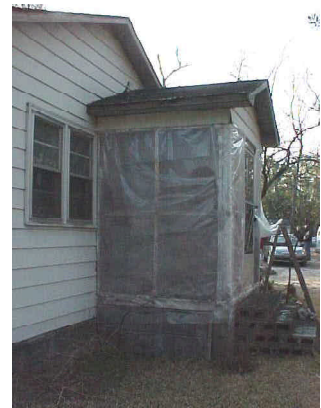
As mentioned previously, the Inspector first performed an exterior evaluation of the home. The evaluation included drawing a plan of the structure and identifying the window sizes and styles. At the same time, he examined the exterior of the home for hazard mitigation opportunities. Consistent with his focus on the higher risk wind hazard, the Inspector noted the need for roof repairs.

The exterior of the home appeared to be anchored properly to the ground and the side sheathing was in fair condition. The doors and windows were

noted as poor from a wind-risk mitigation perspective but would probably be replaced as part of the WAP. There was little to no debris on the property.
